Technical Assessment for the CPC FD-7x-1500 Wind Turbine Located at Tooele Army Base, Tooele, Utah

August 2012

**Idaho National Laboratory
Idaho Falls, Idaho 83415**

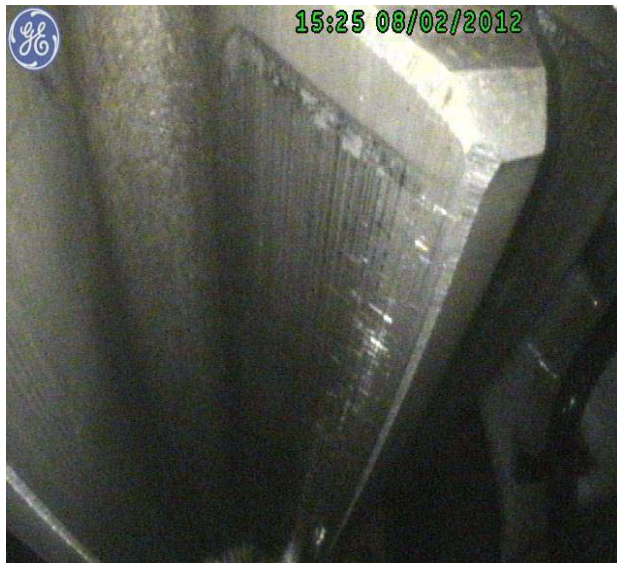
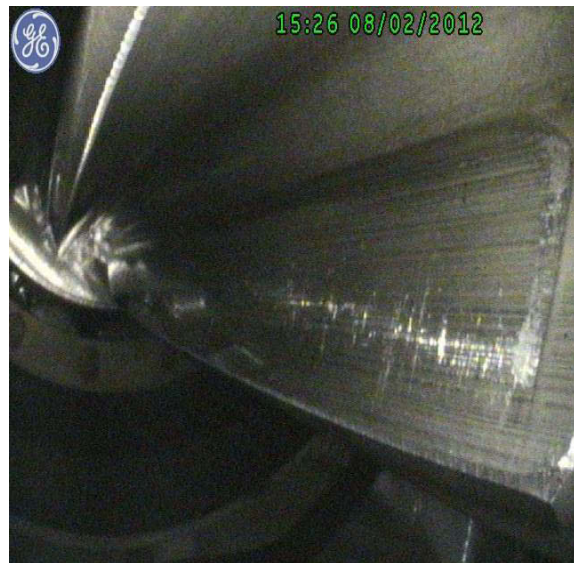
High Speed Pinion Picture 1

The High Speed Pinion showed somewhat heavy scuffing (Pictures 1&2); Intermediate Wheel and Low Speed Wheel showed minor adhesion (Pictures 3 thru 8), High Speed Generator Side bearing and Low speed Rotor side bearing showed mild scoring on the rollers (Pictures 15 thru 24). Our feeling is that this wear is within typically normal bounds for a wind turbine gearbox, but likely on the high side of normal wear for the amount of time this turbine has run so far. This may be due to the gusty nature of the wind resource at Tooele, or could be an indication of gear material quality to watch over time, but this may be just speculation. We recommend regular inspections of the gearbox, lubrication fluid testing, and making sure that all of the turbine lubrication systems are checked and verified to have been performed on the manufacturer-recommended intervals.

4. Gearbox defects may lead to potential damage if not monitored.
 - a. Borescope re-inspections in 12 months to monitor the condition of the gearbox
5. Gearbox oil analysis should be conducted.

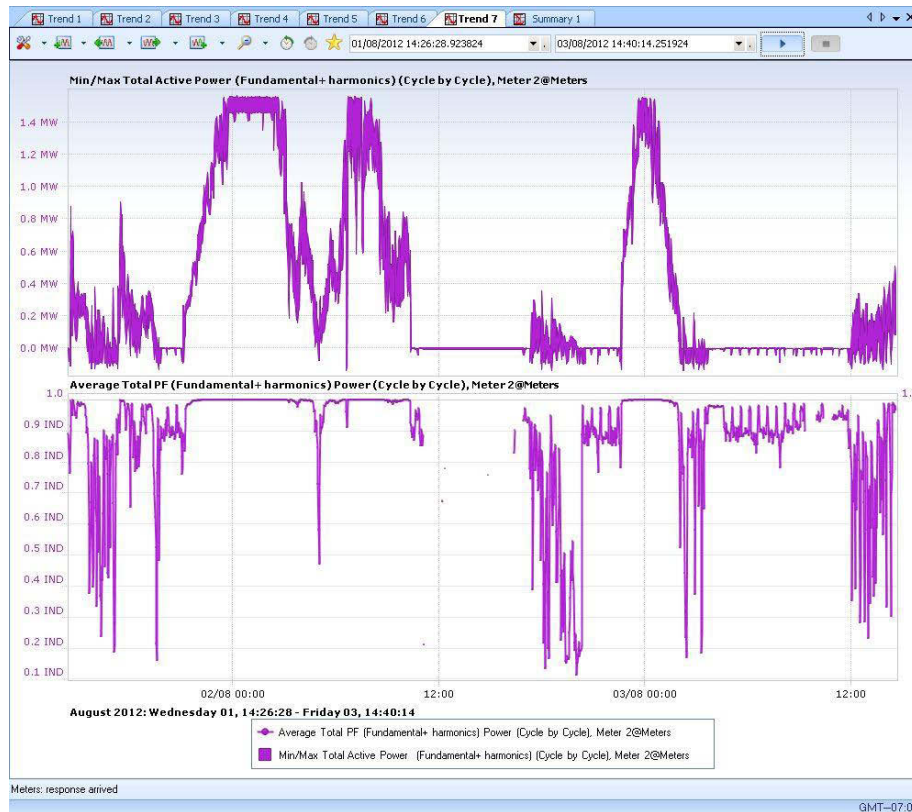
Figure 1: Active Power and Power Factor Plots

The results indicate that the turbine generally has satisfactory power quality, although the power factor at low output power fluctuates a bit more than is typical for a doubly-fed induction generator and power electronics system. The power factor at higher output power is very stable. The power factor at low output power varies quite a bit, more like a standard induction generator wind turbine with switched capacitor banks, without the finer power electronic controls and capacitor bank/stages sizing. Harmonics appear to be within acceptable ranges. Even though the power factor fluctuated at low power output, the system voltage was relatively stable overall at

the measurement point. Feeder and power system voltages around the Tooele distribution system should be monitored periodically in the future, and if there are power quality or voltage concerns, system designers may revisit the turbine power controls or other system voltage control methods and equipment for the Base and between the Base and service utility. Figure 1 shows plots of the measured output power and power factor from the wind turbine during the test period. Figure 2 shows plots of the measured current and voltage from the wind turbine during the test period. Other plots of voltage, current, harmonics and other parameters are available on request.

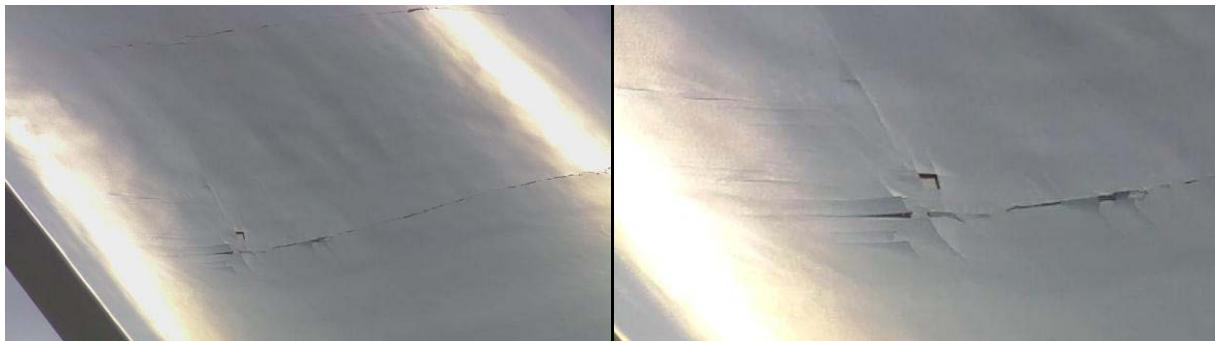
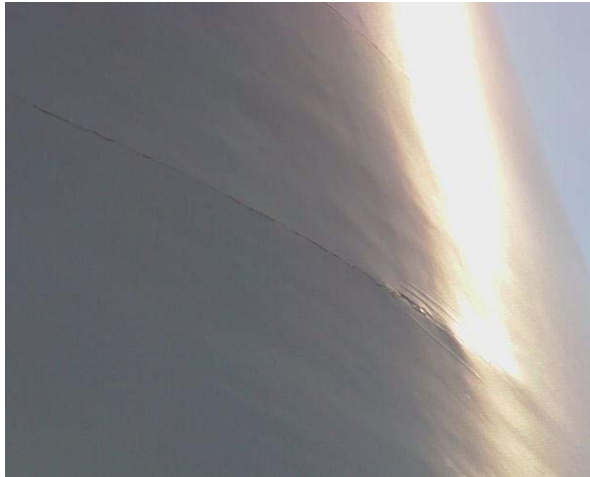
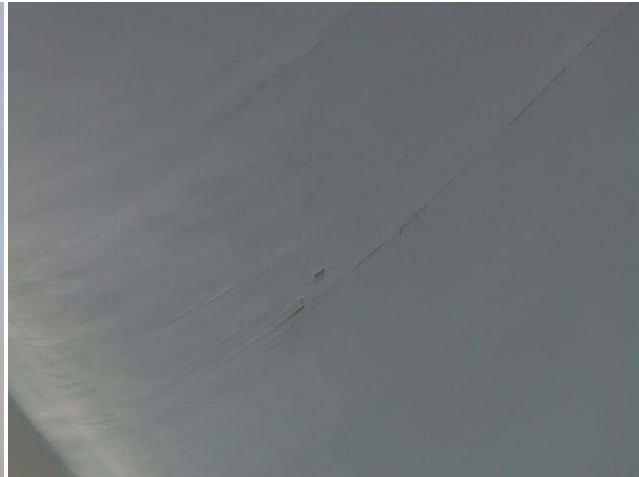
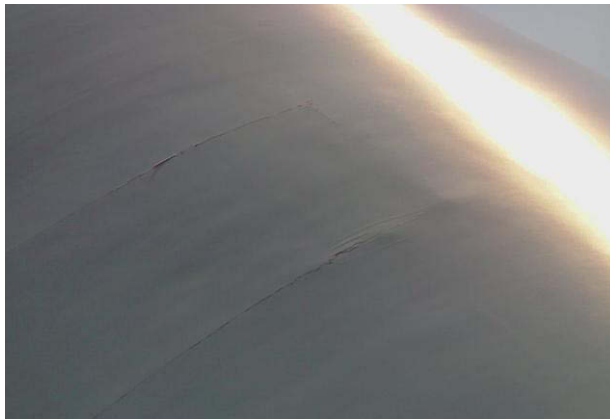
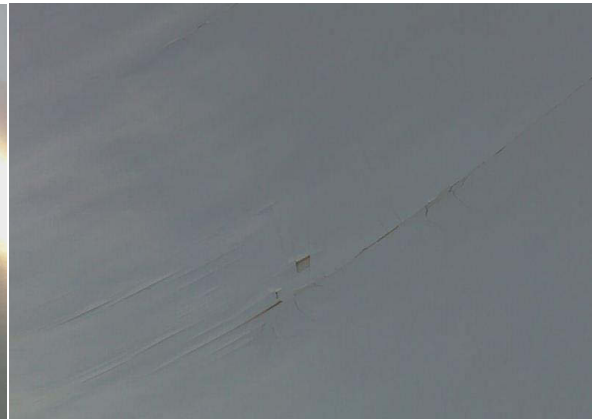
5. One of the turbine blades is in need of significant repair. The cracking and peeling appears to be mostly on the surface and not structural, but could not be confirmed by INL, as the close-up inspection and report had been performed by others and INL has not reviewed the report. Moisture/freezing, temperature changes, and prolonged operation of the turbine will likely exacerbate the problem. This blade damage was identified before warranty was up, so should be repaired or replaced as soon as possible under warranty. There will likely be disagreement between the manufacturer, potential repair subcontractors, and the original turbine installation contractor as to the severity of the damage, what caused it, and how it should be repaired. The Army should stay cognizant of this, but insist that it be repaired or replaced to the satisfaction of a quality inspection by a qualified subcontractor to the Army, and should come with at least a one year warranty extension on the blade/repair. The other two blades have spots that also need surface repair. It appears that some of the damage is in areas where lifting or storage straps would have been placed on the blades, and indications of strap marks are left in those spots. Normally lifting would not cause undue stress on those parts of the blades, but prolonged flapping of straps on a spot during winds and storage/shipping could cause some extra stress, or poor original surface quality could potentially be impacted during a strap lift.

The blades were visually checked and found some cracks which need to be repaired ASAP, Pictures B1 thru B6 Illustrate the cracks on the blades.

6. The blades need to be inspected and repaired ASAP; if further spalling or delaminating occurs, the blades may not be repairable.
7. A better set of spare parts should be funded and obtained, especially with some of the larger items that might have a higher probability of replacement frequency, such as pitch motor, yaw motor, hydraulic pump/motor, pitch motor cooling fan/motor, yaw plates, etc. Checking with the manufacturer, OEM suppliers, and/or the selected turbine O&M contractor for recommended spare parts would be a good first step in developing a better list of spare parts for this turbine. There are several smaller spare parts currently at the site, but these are mostly electrical components.

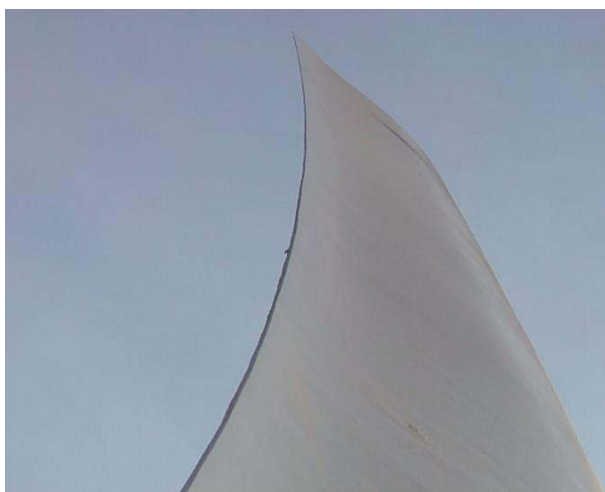
Picture B7 illustrates the marking in the tip of the blade, further inspection is recommended. Picture B8 shows venting on blade has been removed and plugged.

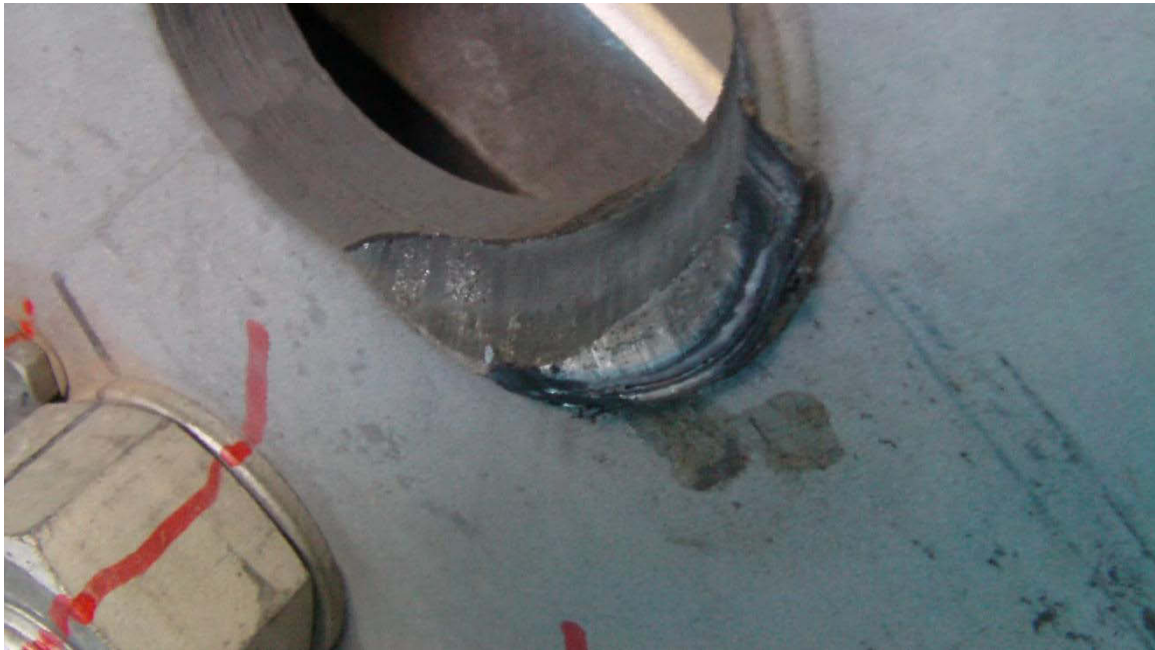
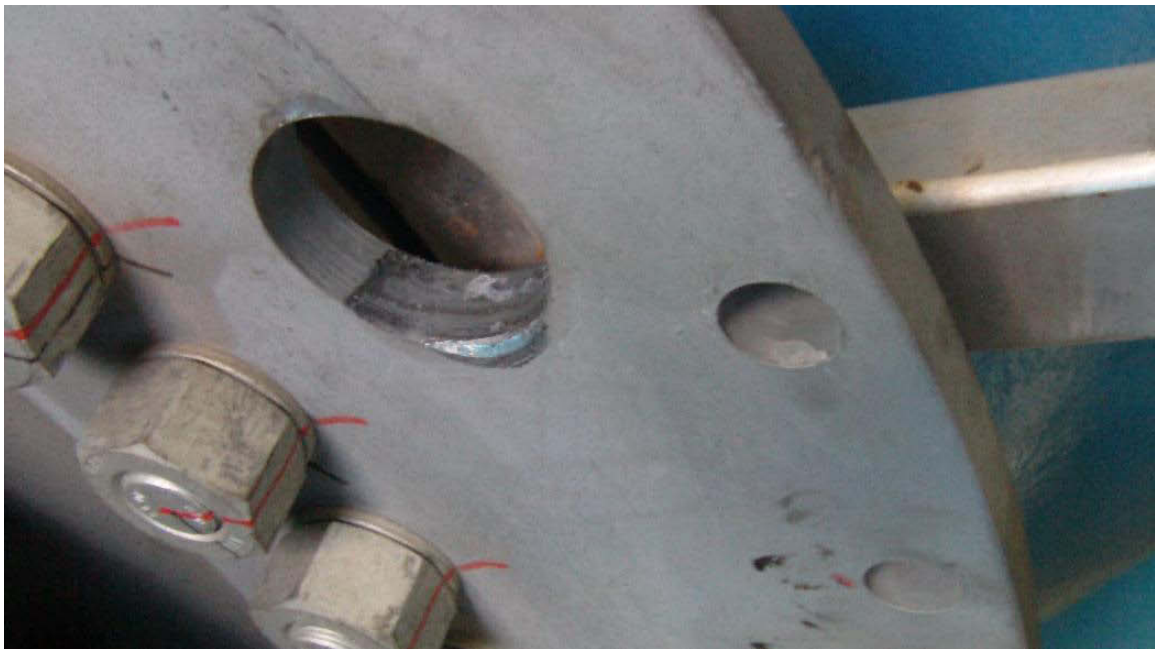
Figure 3: Damage to Rotor Lock Wheel

The inspection team found the turbine to be in generally good shape. The Down Tower Assembly looked good and intact. The team checked all cabinets and saw some rewiring done in the Main Control Cabinet and the Top box Cabinet; photo #001, #002, and #003. The Tower section and platforms also looked good, although there were a few bolts on the platforms and platform door hinges that need to be replaced or tightened. The cables going up-tower also looked to be in good shape; photo #004. The Nacelle is in good shape, but did find the rotor lock missing which was later found in a shed with turbine spare parts; the rotor lock shaft was bent and had to be lathed to temporarily fit back in to lock the rotor for hub work; photo #005, #006, and #007, and also see additional photos. A new rotor lock shaft is supposedly on order, so should be fully replaced and installed in the future.

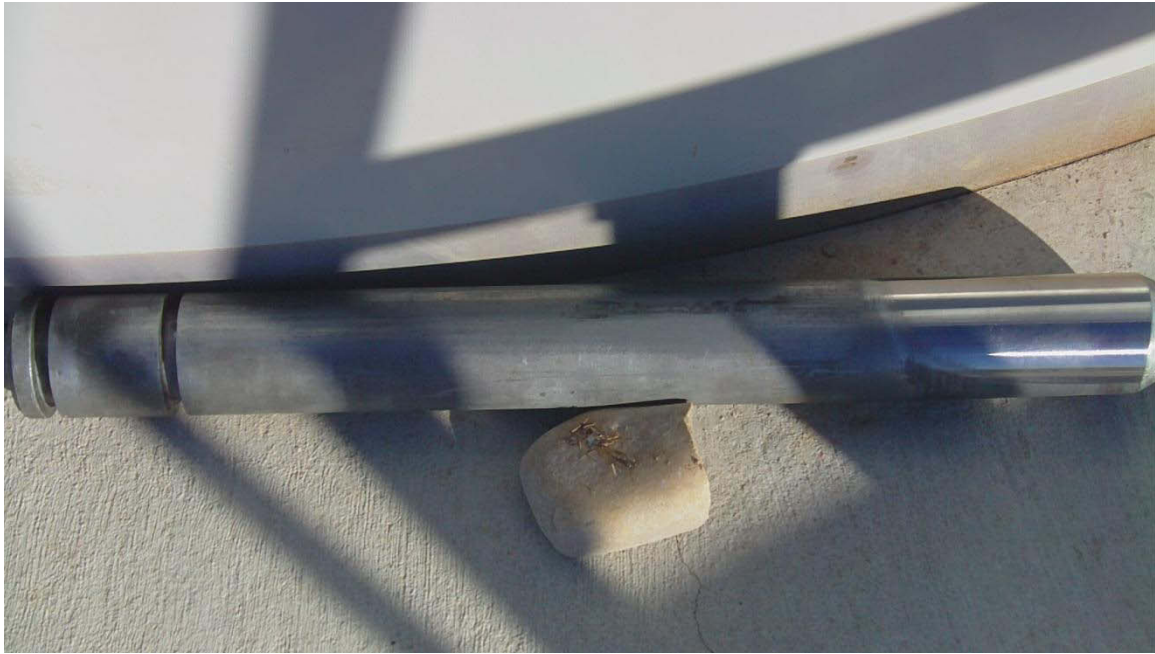
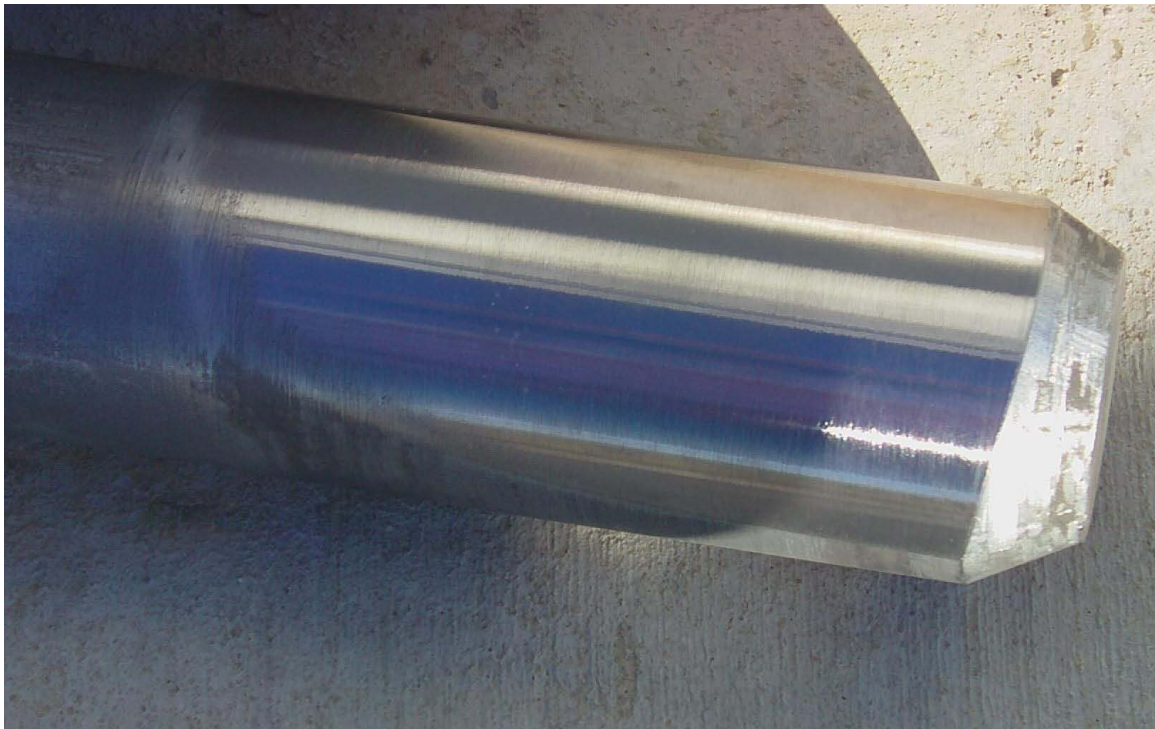
Figure 5: Rotor Lock Shaft Repair

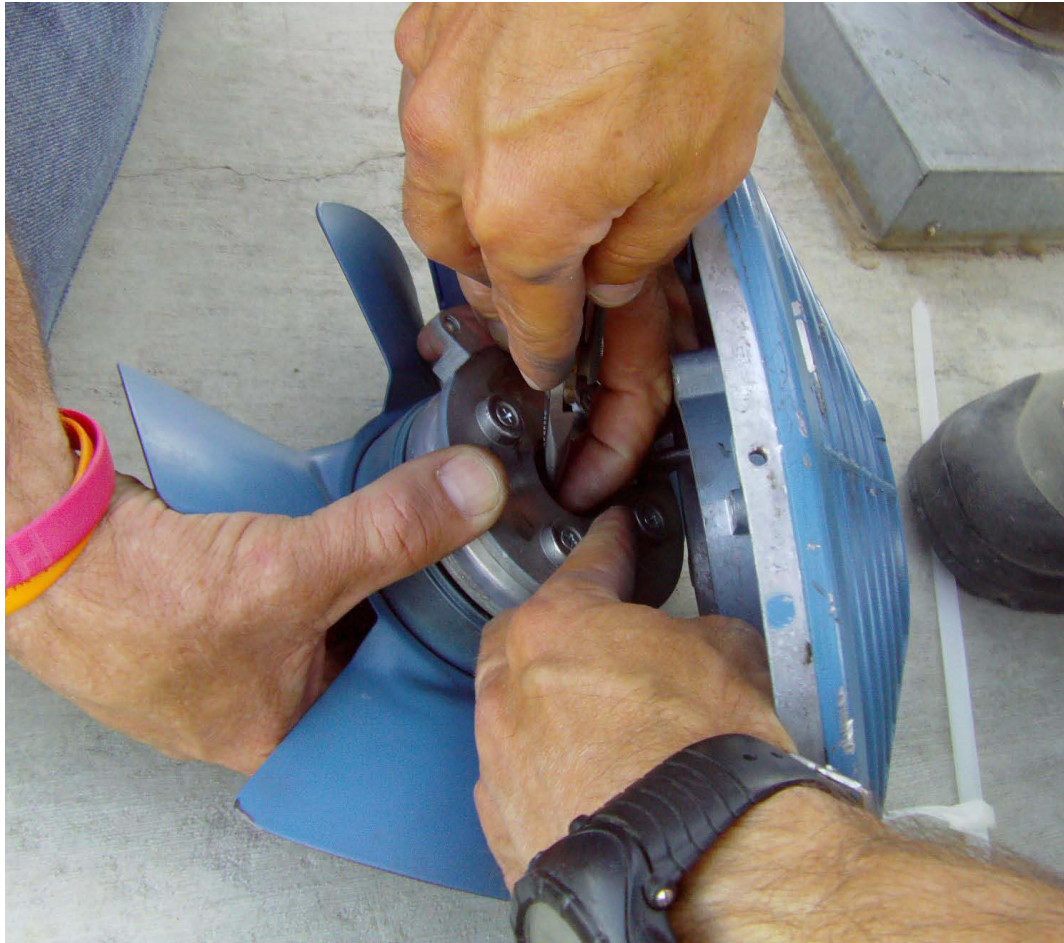
Figure 7: Repairing Cooling Fan for Pitch Control Motor

4. The jammed cooling fan/motor on the pitch motor found by INL in August 2012 was caused by a missing snap ring on the end of the fan shaft that should hold it in place on the back end of that motor. It appeared that this snap ring was never there, as no broken ring parts or shaft marking could be found. This motor and pitch control assembly in the turbine hub were from standard OEM suppliers for many wind turbines. It appears that QC checks from the original supplier and the final turbine manufacturer/integrator missed this issue. It also went unnoticed for almost two years of turbine operation and warranty repair/maintenance. Since this would lead to intermittent problems and error signs depending on ambient and system temperatures, it could be difficult to diagnose. Also, since the turbine has run well since this repair,

The high-speed brake caliper had leaked at some point, techs found hydraulic fluid on the tray underneath the gearbox; photo #008 and #009. The hub is in good shape overall. The team did find wires inside the center pitch control box with cracked and peeling insulation and a loose connection, the team taped the wires with electrical tape and fixed the connection; photo #010 and #011. The turbine faulted on PCS errors (codes “Pcs Any Error”, “Pcs Failure A”, and “Pcs Failure B”), which after 15 min. the turbine reset itself and started up. The team found one of the pitch motor cooling-fans to be jammed inside its casing which caused the pitch motor to overheat

and fault out the pitch controller. The team repaired the cooling fan; photo #012. The turbine had a fluctuating rotor speed rpm, the team cleaned and adjusted the rotor speed sensor which fixed the issue; photo #013. The team performed a Generator alignment check and found the generator to be well within tolerance; photo #14.
